REMEDIAL SITE ASSESSMENT DECISION - EPA REGION IV

EPA ID: TND980844229 Site Name: HOOKER ROAD BRIDGE DUMP

Report Type: SITE REASSESSMENT 001

CERCLA SITE REASSESSMENT
HOOKER ROAD BRIDGE DUMP
CHATTANOOGA, HAMILTON COUNTY, TENNESSEE
TND 980844229

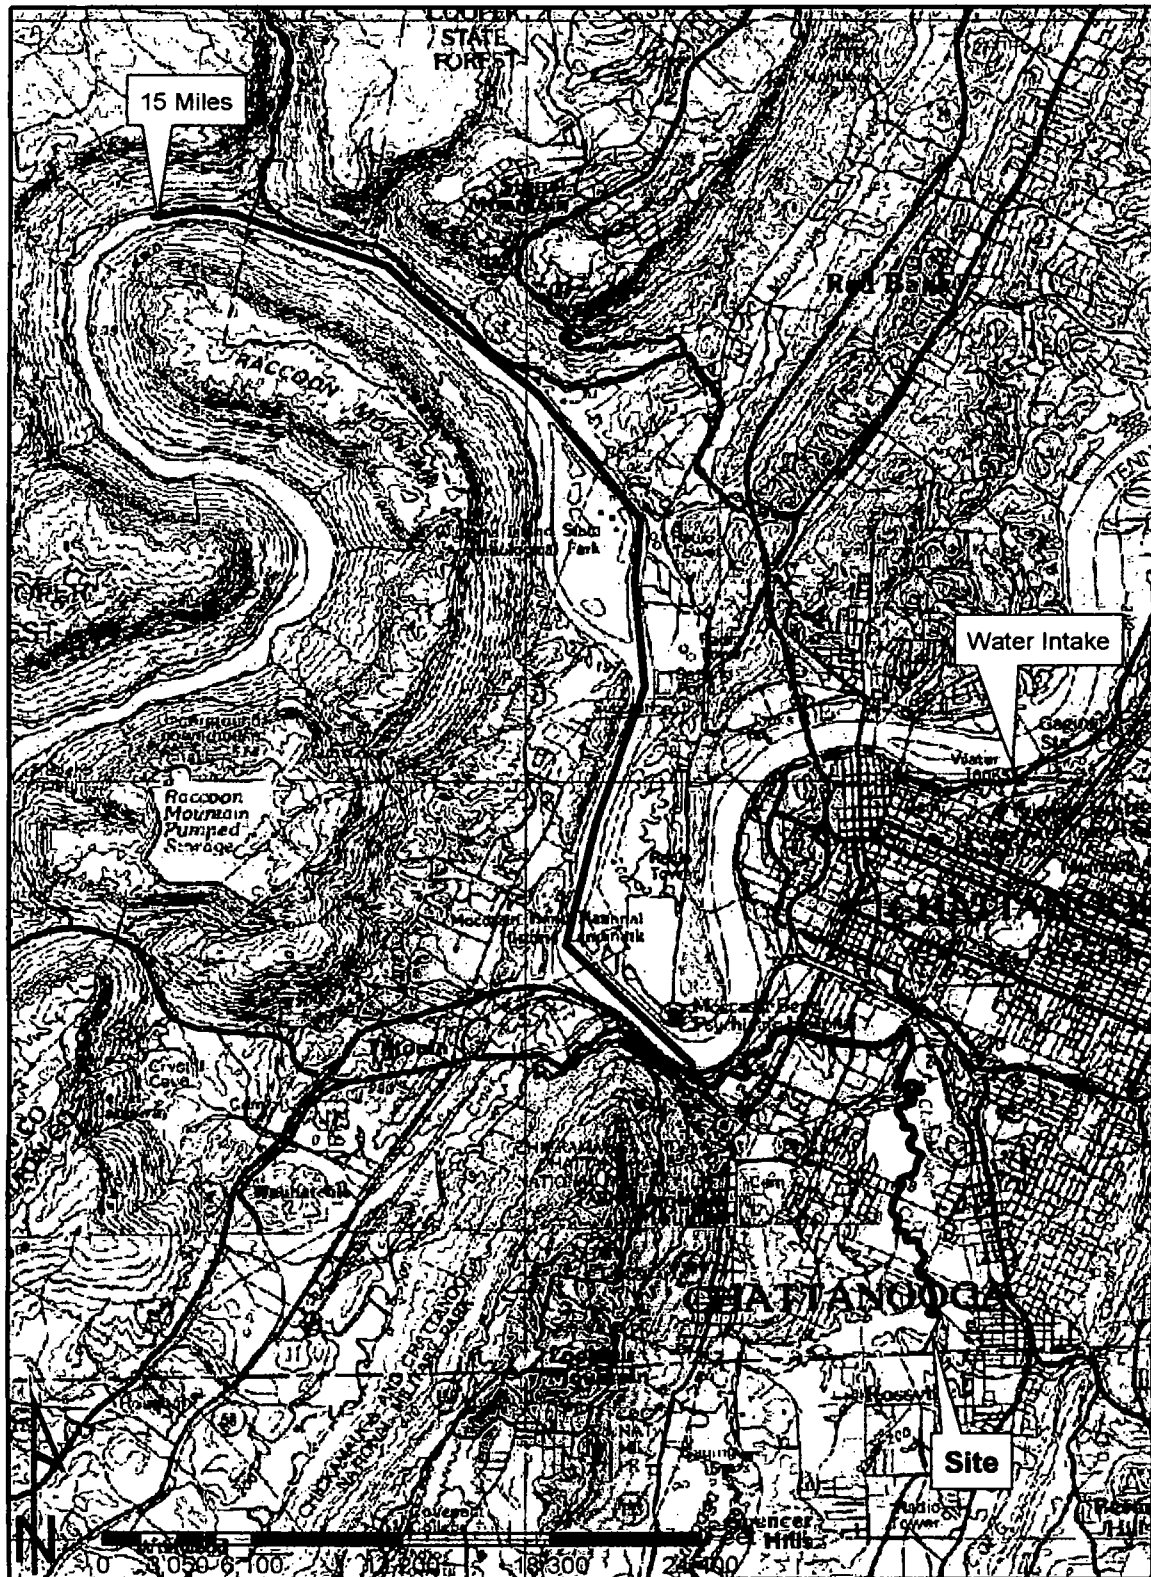
Figure 3

There is no surface water intake located within the 15-mile downstream segment (Figure 3).

The average flow of the Tennessee River is 36,650 cfs, and the average flow of the Chattanooga Creek is 125 cfs. The Tennessee River is used as an industrial and drinking water supply. It is used for fishing, recreation, and irrigation, and it is a water source for livestock and wildlife (Reference 1). Chattanooga Creek has been heavily polluted by local industrial activity and is currently on CERCLIS. Chattanooga creek is a posted creek and a NPL site. There are approximately 16,000 feet of National Wetlands Inventory wetlands along the Chattanooga Creek down gradient from the Site.

**Surface Water
Pathway**

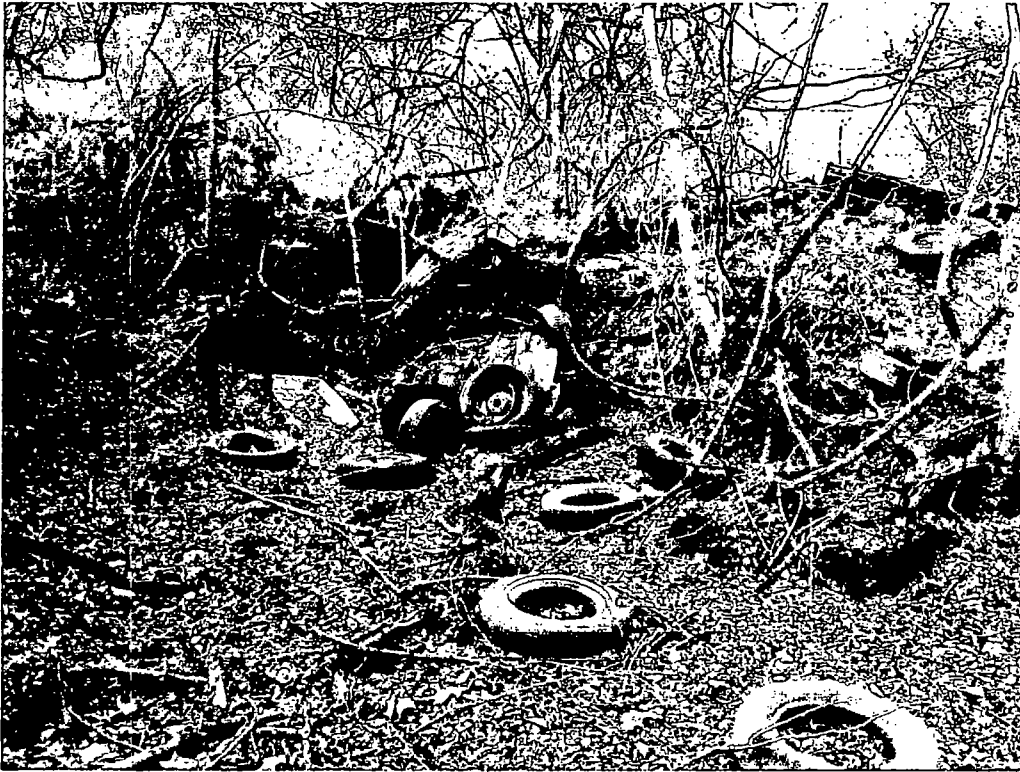
Photo 1. View of tires and debris. Photo taken by J. Barrett.

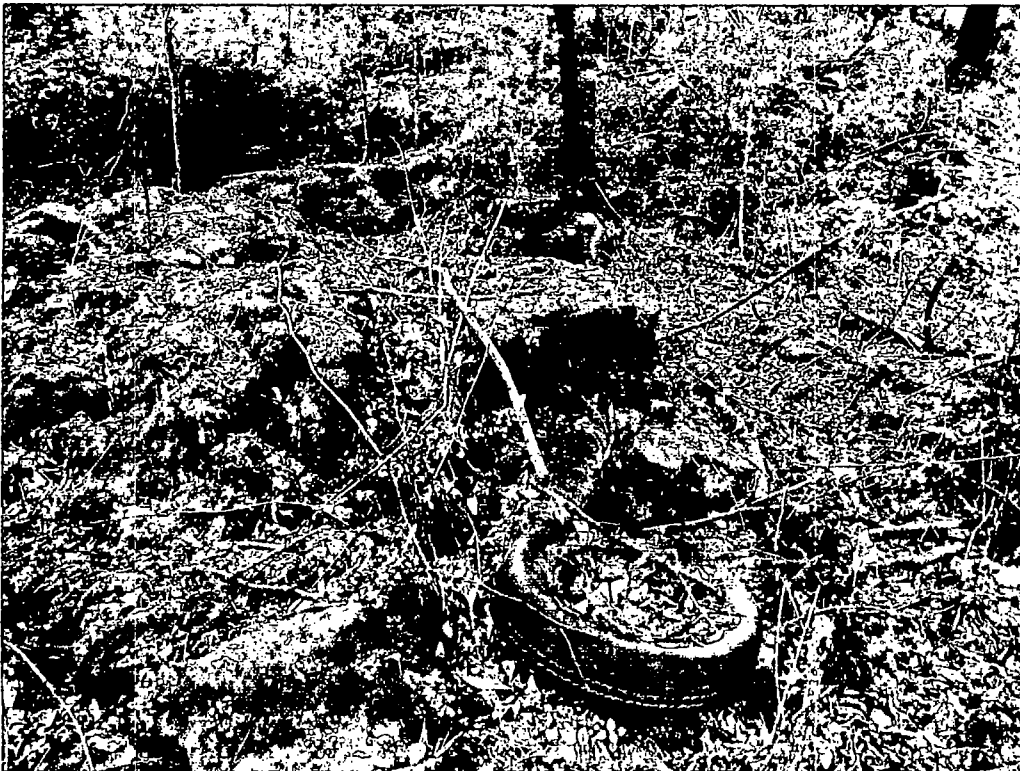
Photo 2. View of view of carpet backing. Photo taken by J. Barrett.
